Adam Afify is at Binghamton Johnson City Waste Water Treatment Plant. ...

1. Headworks leaking wall Picture #1, with electrical panels. –

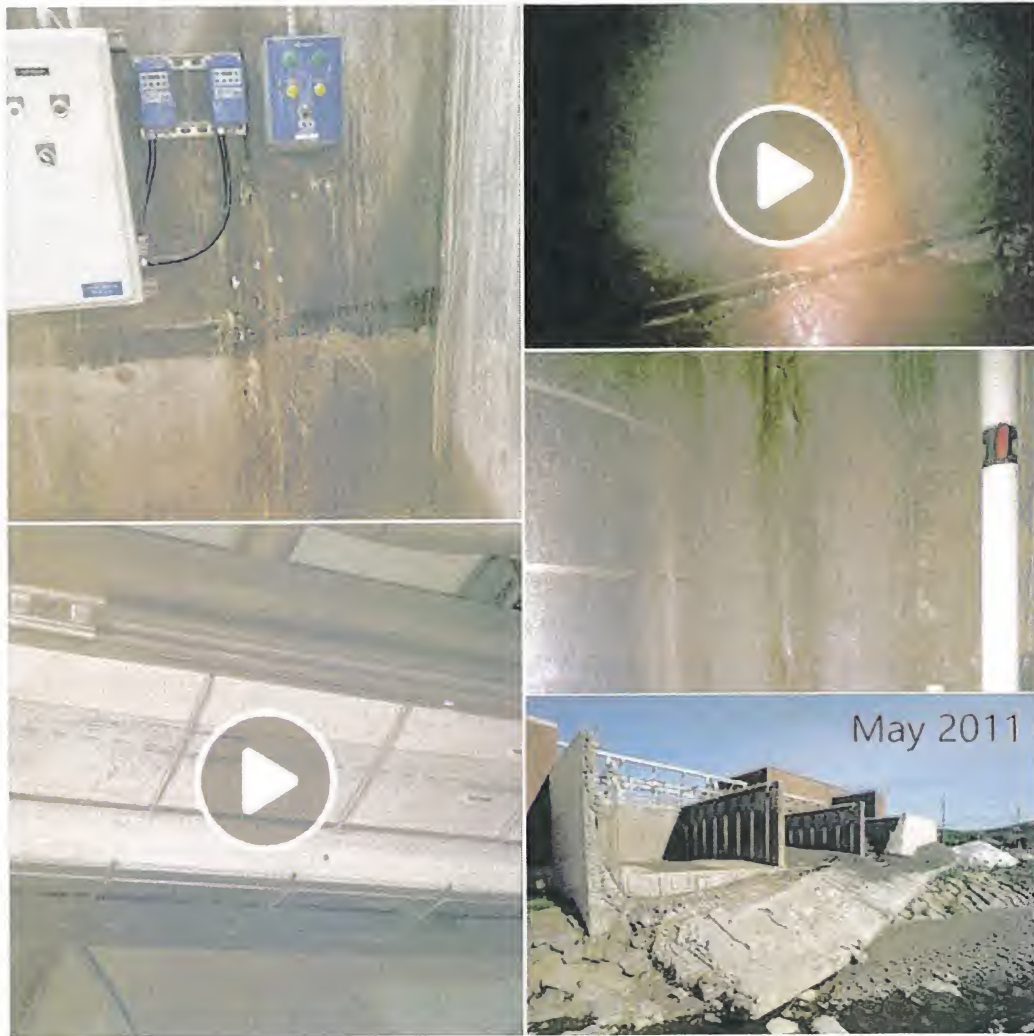
Alleged Condition – STP Staff alleges that the wall is leaking and is shoddy construction.

Actual Condition – This photo appears to be several weeks old. The headworks was put into service June 26 It does not show the completed work, and does not show that the leak has been addressed. The wall that the panels are located on backs up to the north grit channel. See attached drawing. The leak test on the channel was passed in January, 2019. All visible leaks were sealed at that time. At the time of the photograph, there are no visible leaks, just past leaks that were appropriately sealed during construction.

Alleged Condition - STP Staff also suggest that the control panels are covered in residue, and implying that they could be damaged.

Actual Condition – The issue is cosmetic, and it was addressed on the day that the picture was provided. These panels are not damaged. The streaky appearance is from water from the core drill process above the panels which ran down the wall. These panels have already been cleaned

up, and were not damaged in any way. The panels were inspected after the drilling process, and it was confirmed that the panels did not have any intrusion of water into the panels. Furthermore, the manufacturer certified the installation of the panels prior to putting the Headworks on line on June 26, 2019, and they confirmed that there were no warranty concerns.

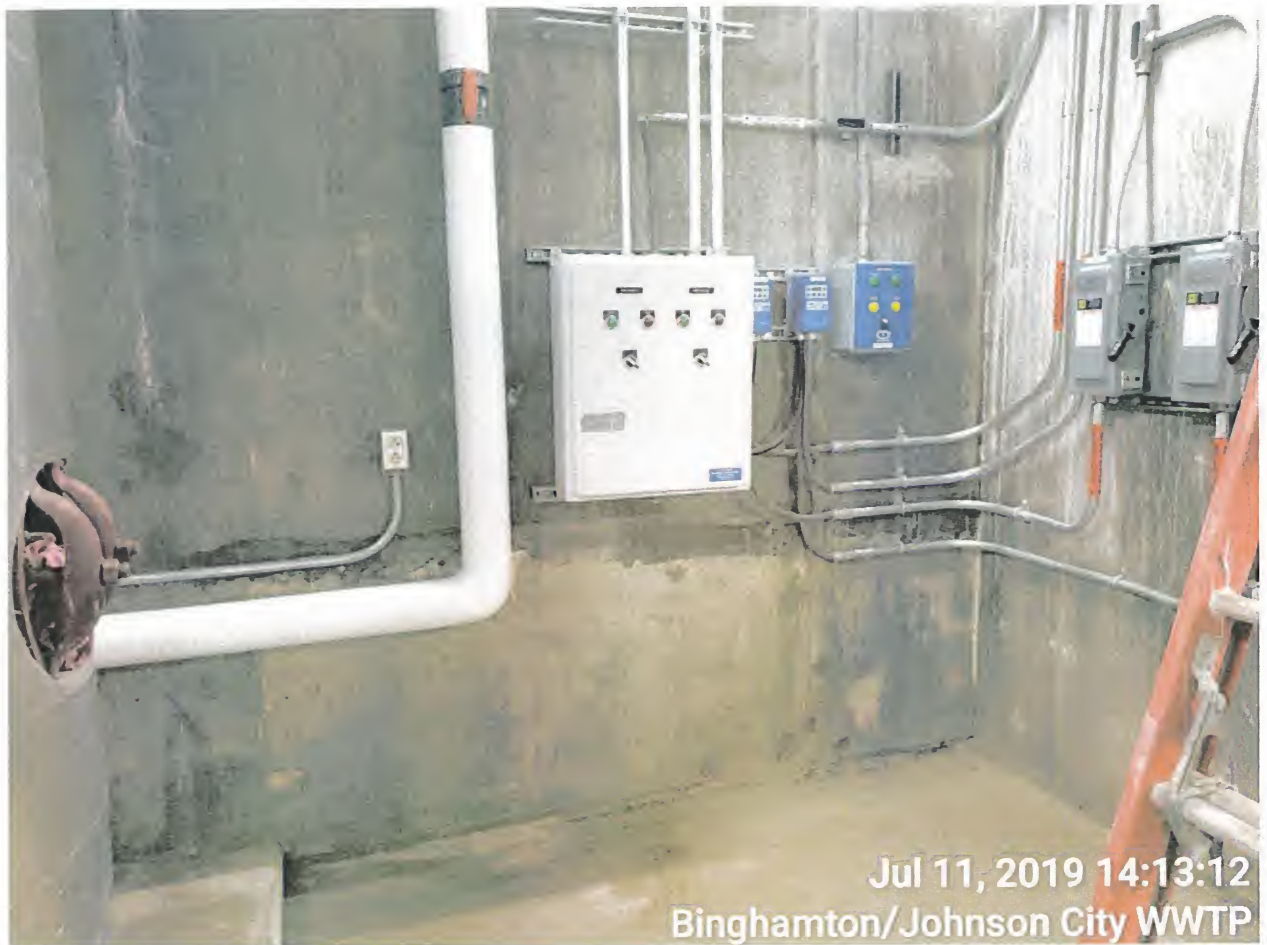
2. Headworks leaking wall Picture #2 with Insulated Hot Water Pipe. –

Alleged Condition – The text indicates that the wall is leaking and is an example of shoddy concrete work.

Actual Condition – This wall picture is directly adjacent to the picture in item 1. It is not more than a few feet away from the picture above. See attached photo. As we have said before, it is not uncommon for concrete to leak water after it has been cast. That is the reason that we specify that a leak test be performed for all water holding structures, and for all visible leaks to be fixed on concrete structures. There are standard commonly accepted industry practices for sealing leaks in concrete. A person knowledgeable of the industry would know about these industry accepted leak sealing products. As stated above, any leaks in the wall were sealed several weeks or even months ago. The leak in the wall could not be discovered until the leak test of the grit channel. The leak test was passed in early winter.
